## TAYLOR DAM

NH 00026

### PHASE I INSPECTION REPORT NATIONAL DAM INSPECTION PROGRAM

NOVEMBER 1978

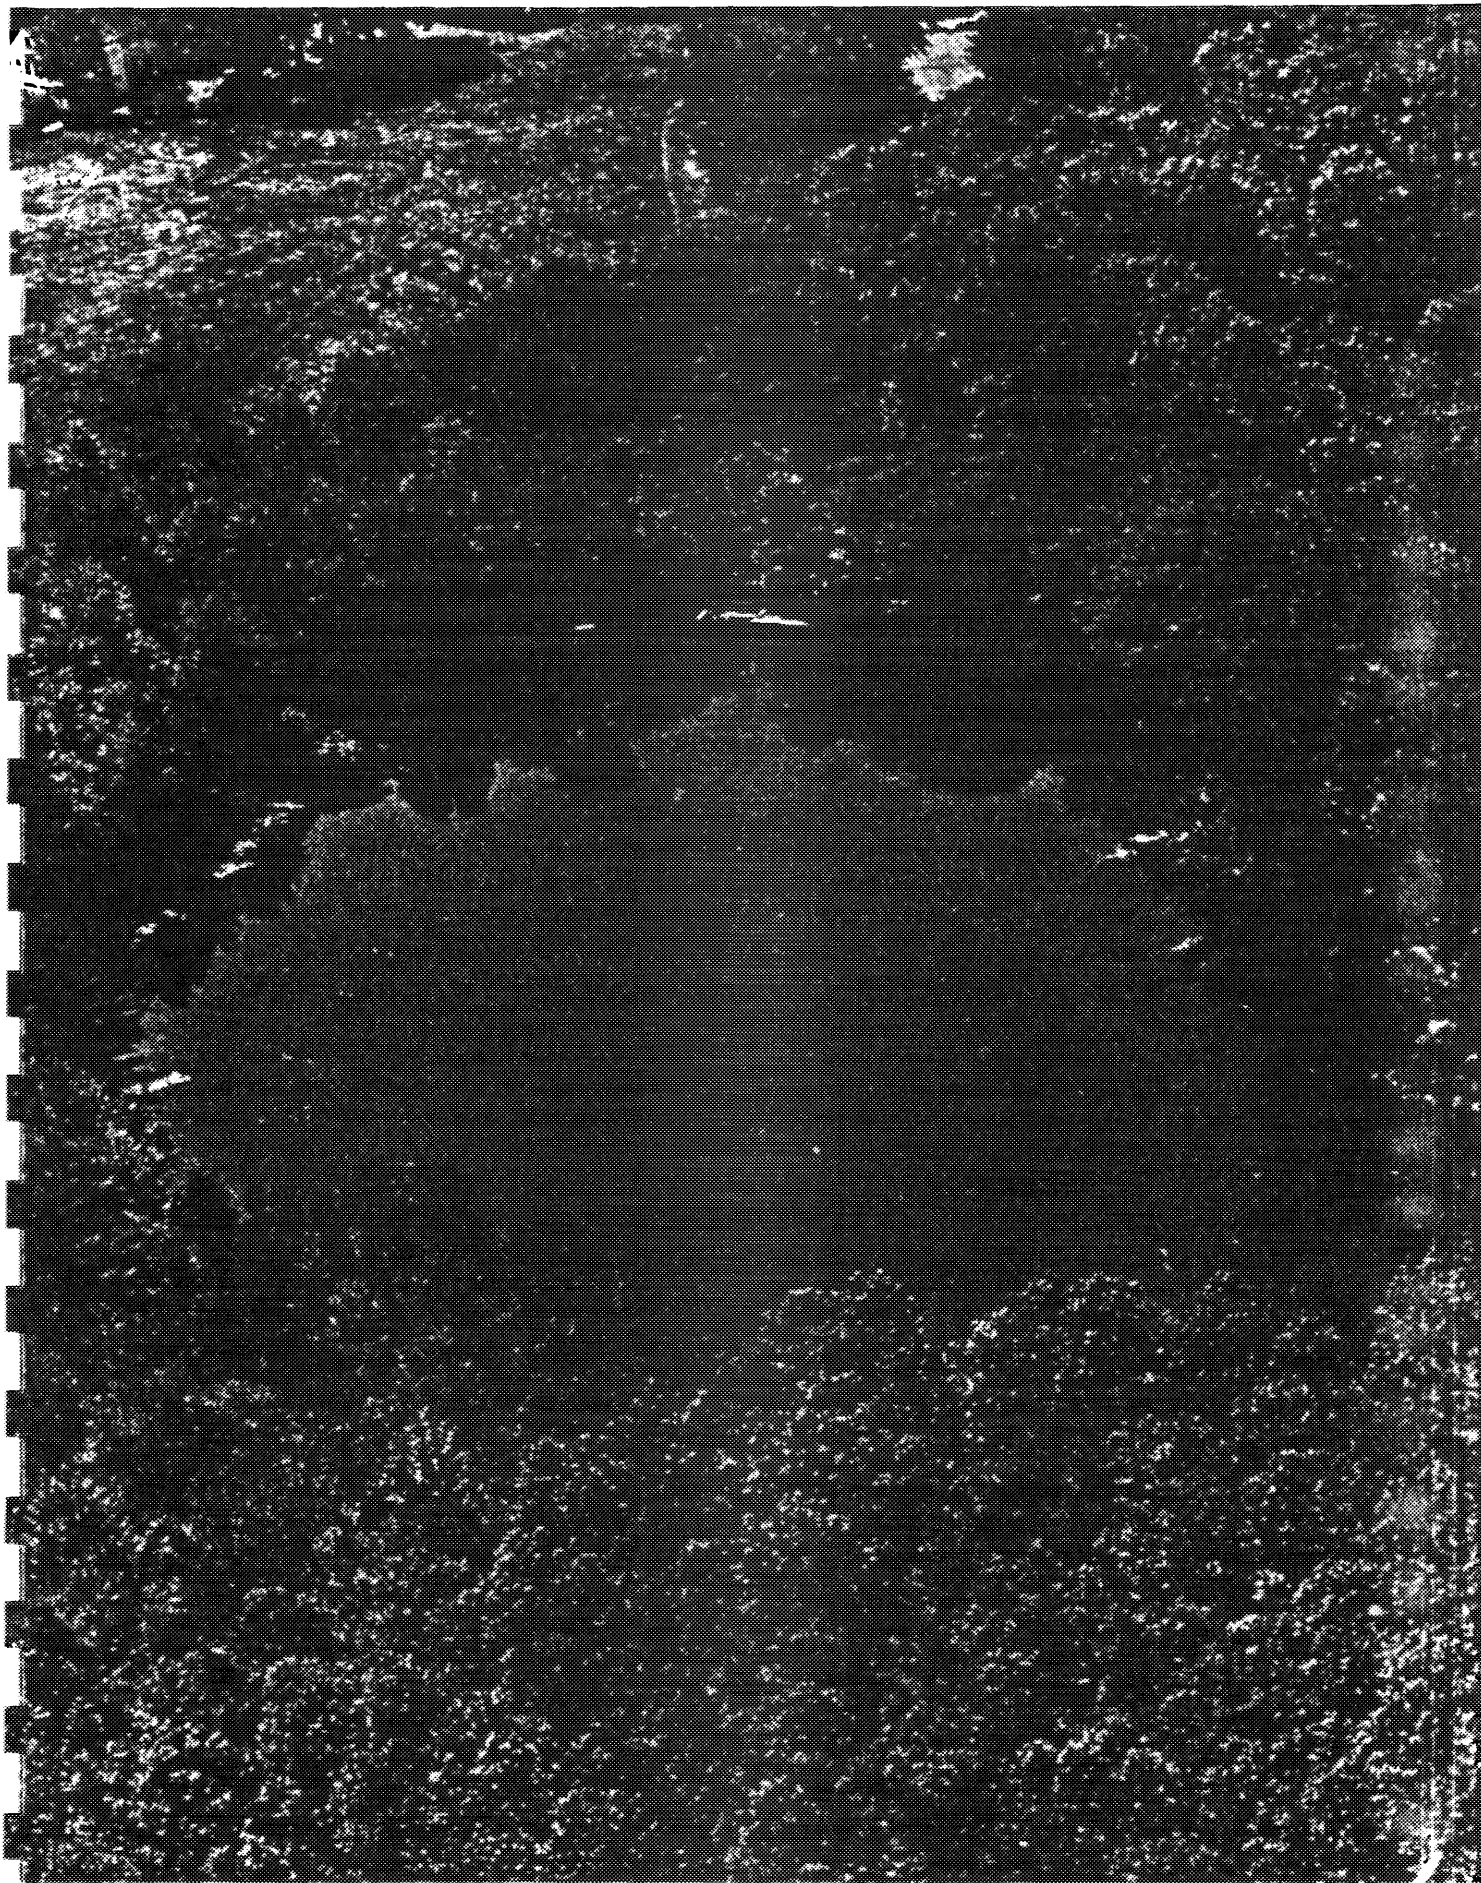
TAYLOR DAM - Overview looking downstream

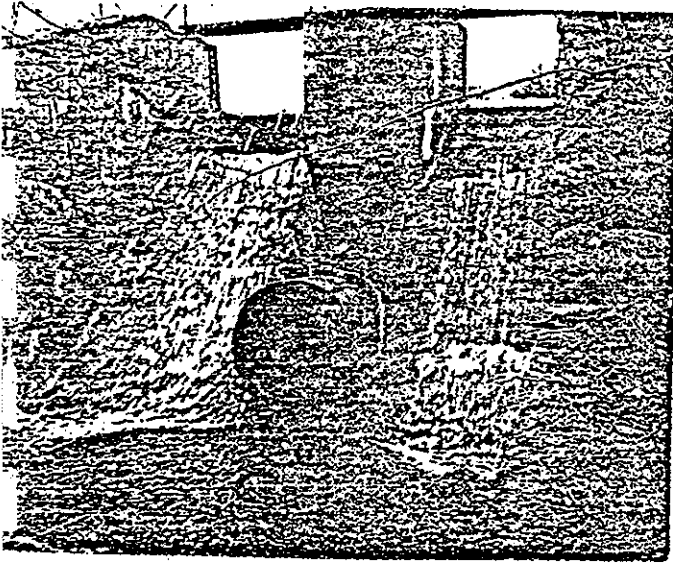
Spillway #2 showing undermining of abutments.

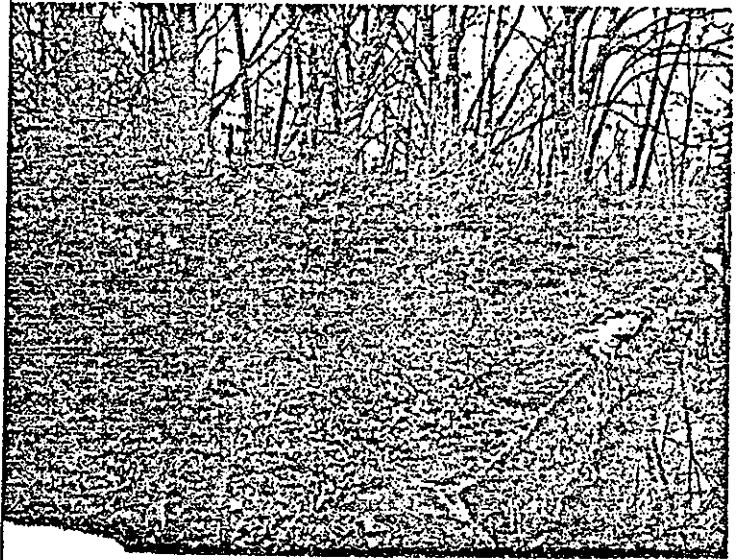
Showing erosion of concrete.

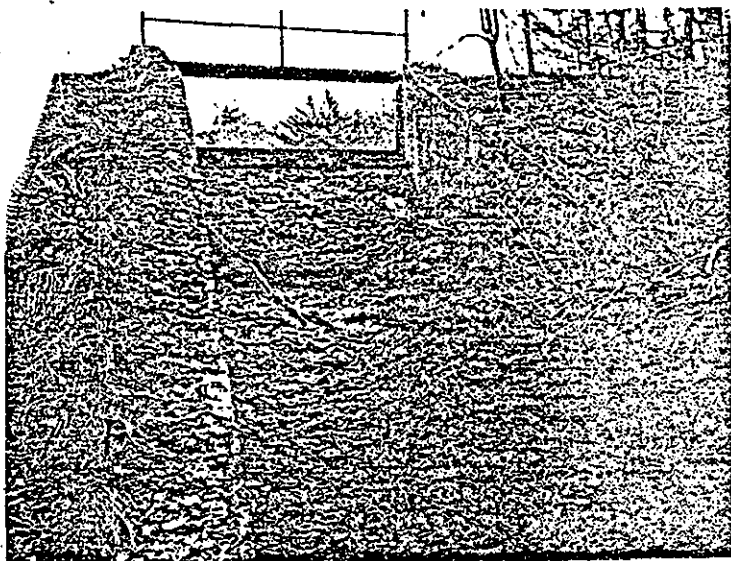
Eroded concrete of spillway #1

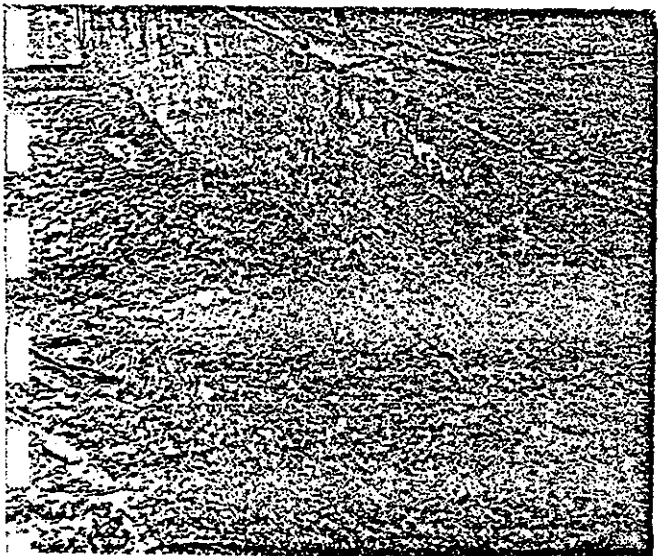
Spillway #1 eroded

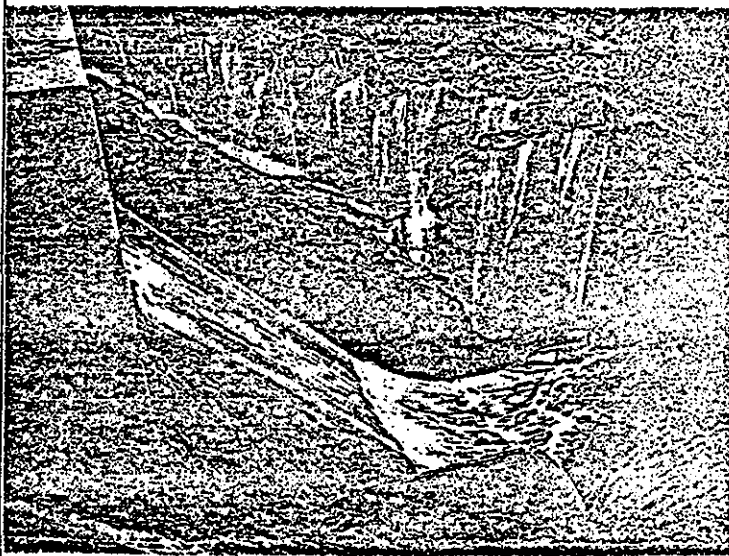
Spillway #2 abutments undermined.

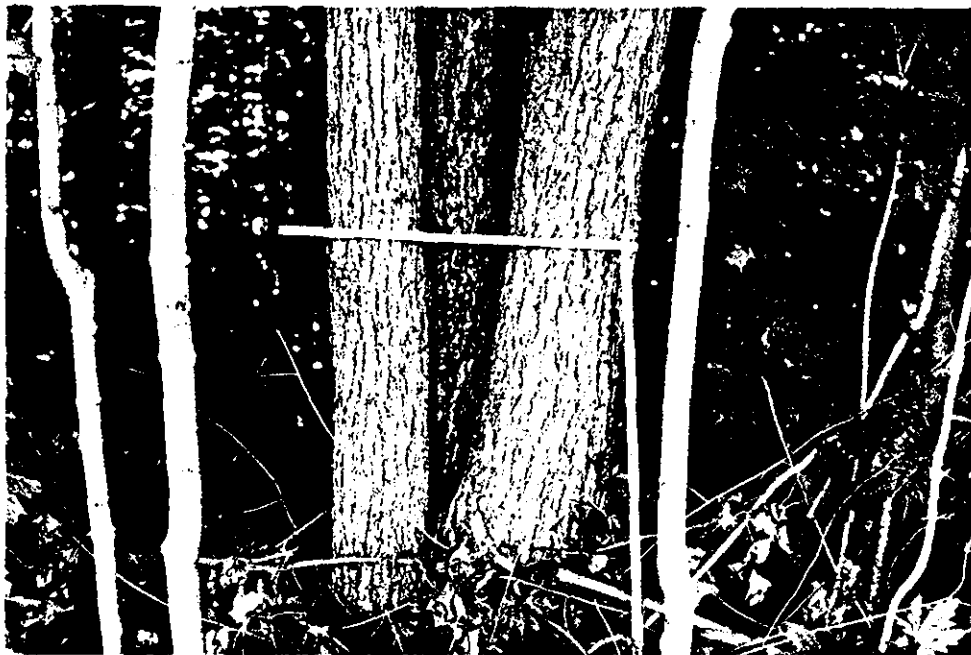
Photo No. 6 - Tree on downstream slope 8 feet from crest of dam. Horizontal rule equals 2 feet.

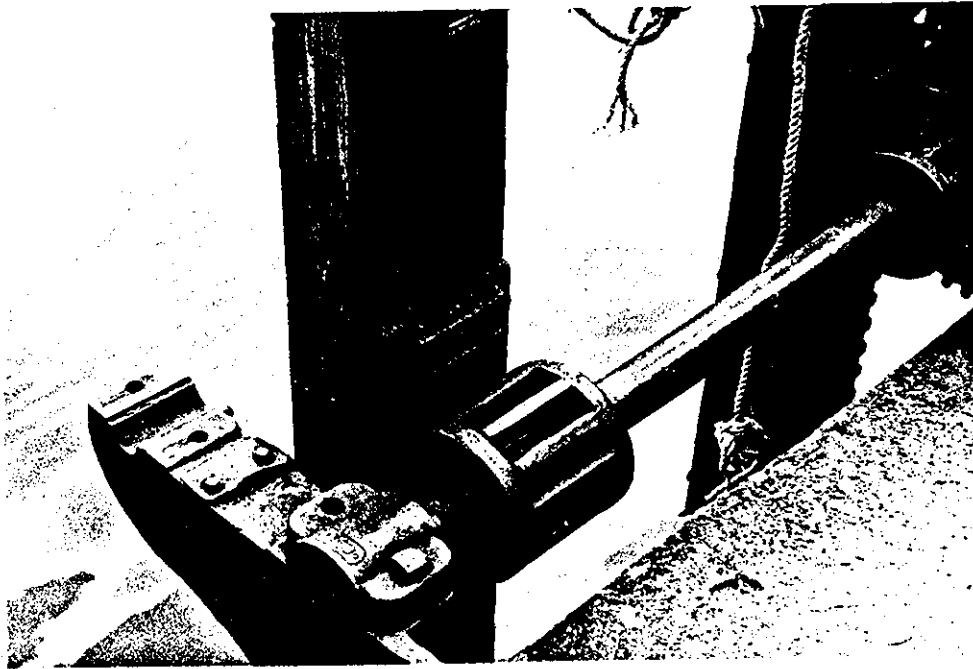
b. Mechanical and Electrical	One gate which is manually operated. Gear mechanism is broken and therefore gate is inoperable.
Air Vents	
Float Wells	
Crane Hoist	
Elevator	Gate is not checked for operation.
Hydraulic System	Only outlet is 60 inch diameter drain pipe in good condition.
Service Gates	
Emergency Gates	
Lightning Protection System	
Emergency Power System	
Wiring and Lighting System

Photo No. 15 - Outlet works gate, manually operated.

(b) Provide the repair or replacement of the inoperable gate to provide for reservoir draining.

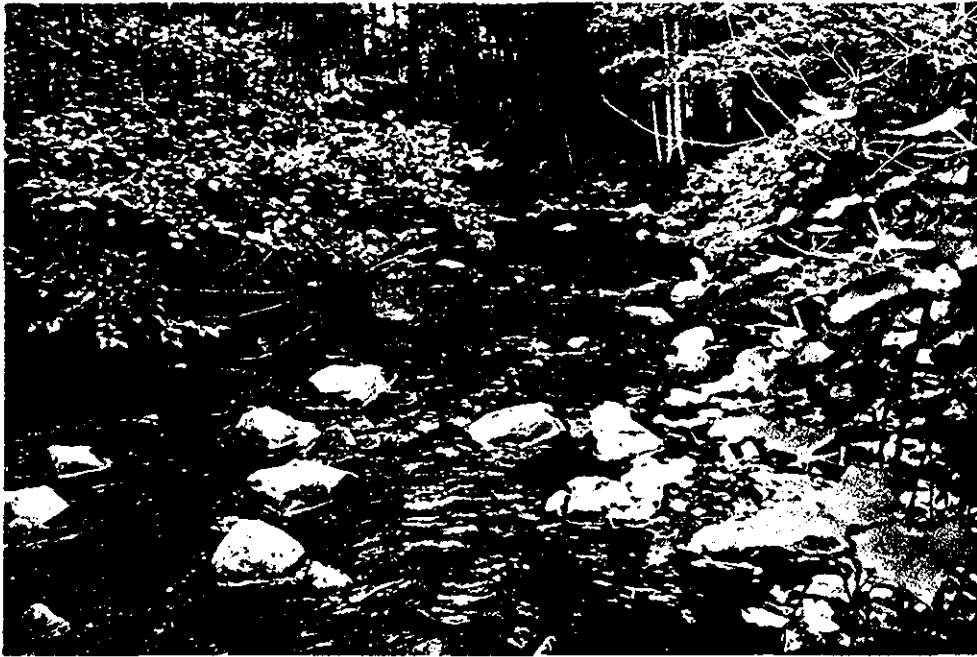
e. Downstream Channel. The downstream channel is relatively free and clear. No riprap covers the floor of the channel immediately below the spillway but erosion appears to be no problem. Some trees are located along the side of the channel but pose no problem to continued free flow. Some erosion of the right bank was noted approximately 400 feet downstream. The channel outlets into Arlington Mill Reservoir about 800 feet downstream.

Photo No. 17 - Downstream channel.
